WDA No 000 Cotton Harvester FEOFMA

Objective. Cotton Harvester Failed Engine Oil Filter Media Analysis Sample from 8/05/2014.

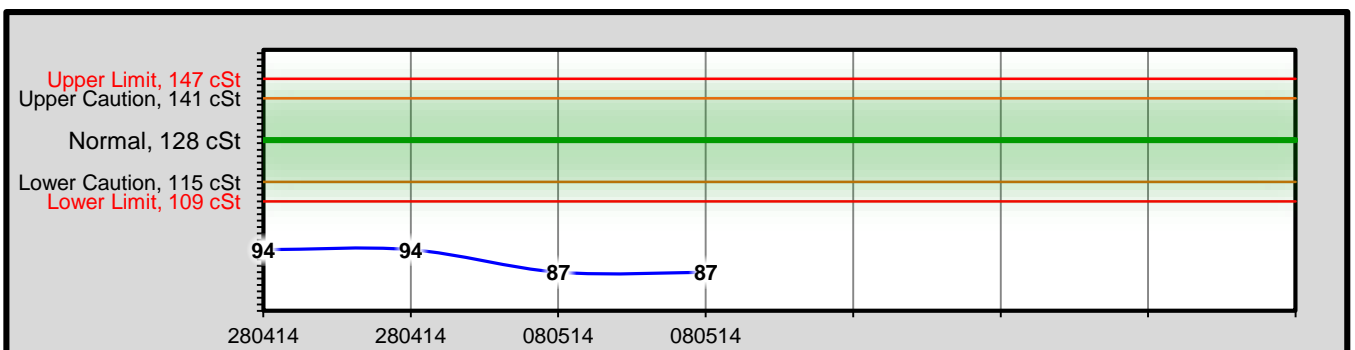
John Deere 50 plus 15w40- Upper & Lower limits, Sample Viscosity cSt @ 40 °C

This engines lubricant was run through the lab on the 28th of April but the highly efficient oil filter was removing the wear debris as soon as it was created, note how the lubricants viscosity has reduced further since the analysis 10 days earlier.

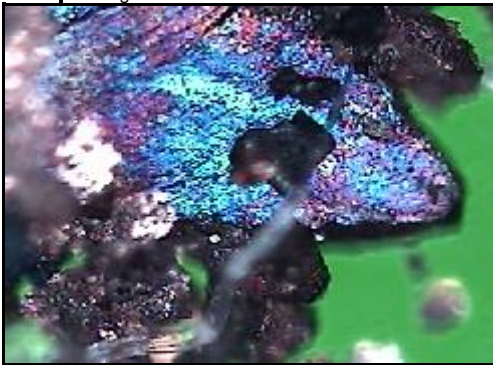
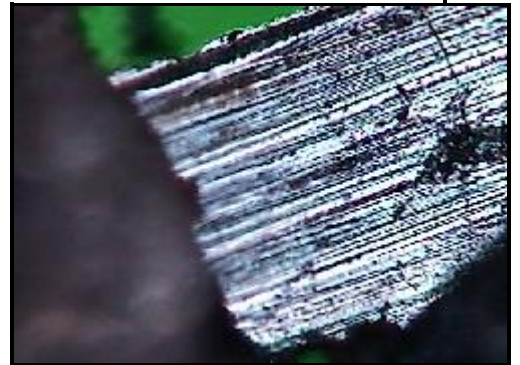
Ferrogram Oil Canister Contaminates

Heat Damaged Lubricant & Abrasive White Metal, Copper & Ferrrous Wear Debris @ 50X Sized 2-600 μ m

There was a heavy amount of heat damaged metallic wear debris present in the sample.

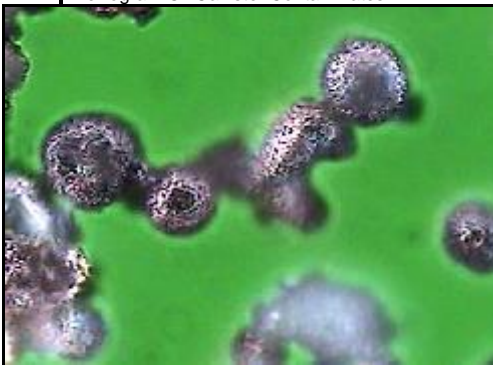
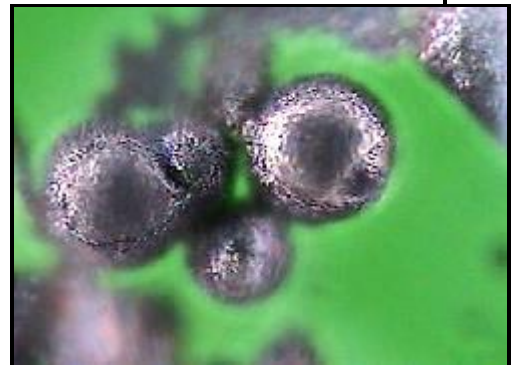
Ferrogram Oil Canister Contaminates

Melted Abrasive White Metal, & Copper Wear Spheres @ 500X Sized 2-90 μ m

There was a heavy amount of heat damaged metallic wear debris present in the sample.

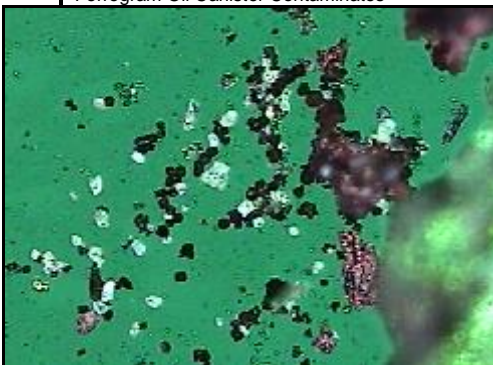
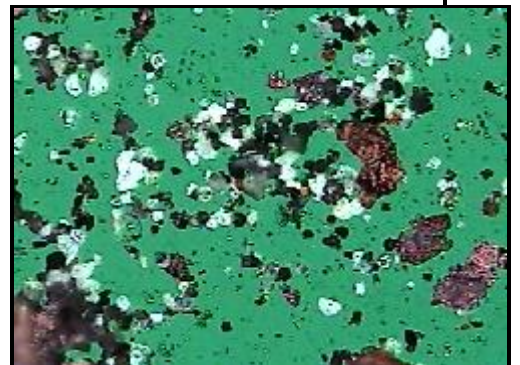
Ferrogram Oil Canister Contaminates

Hard Inorganic Silica Type Crystals @ 200X Sized 5-20 μ m

There was a moderate to heavy amount of this hard environmental contaminate present

The Cotton Harvester failed Engine Oil Filter Sample analysis indicates the engine was dusted and the elevated amount of hard silica type crystals gaining entry have abraded the bearings white metal overlay cutting through the overlay permitting high pressure lubricant to hydraulic the white metal overlay off the bearing shell surface.

The main size range of the hard silica type crystals from the paddock environment was less than 50 µm indicating the dirt has been filtered leading to the conclusion that the existing filter was working but appeared to be grossly overloaded with air filter servicing requiring to be considerably shorter that what was occurring prior to this failure.

After the engine is back in service resample at 50 hours and 250 hours to ensure the air filters are removing contaminates as required for the contaminated environs the harvester is required to work in.

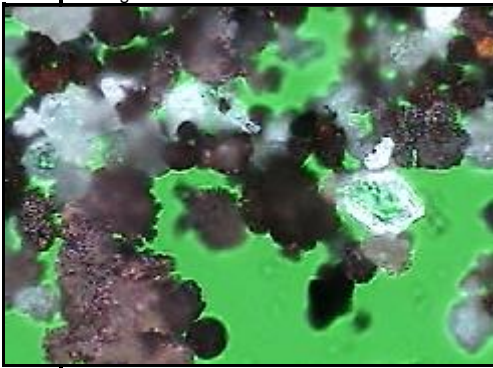
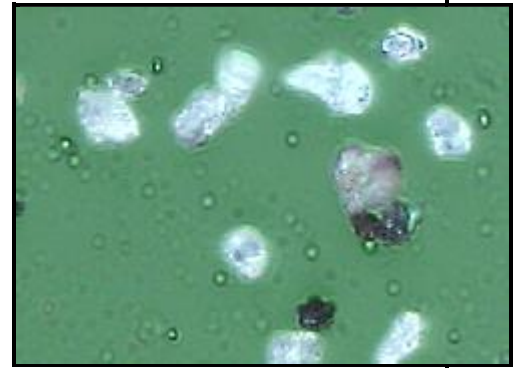
Ferrogram Oil Canister Contaminates

Hard Inorganic Silica Type Crystals @ 500X Sized 2-90 µm

There was a moderate to heavy amount of this hard environmental contaminate present

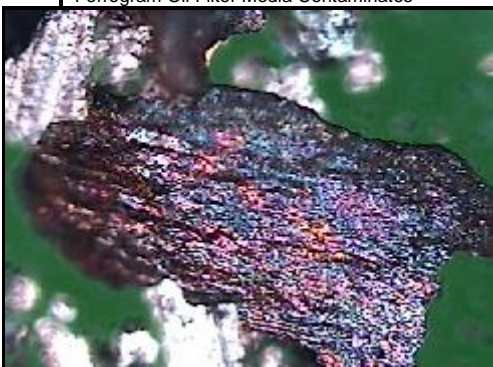
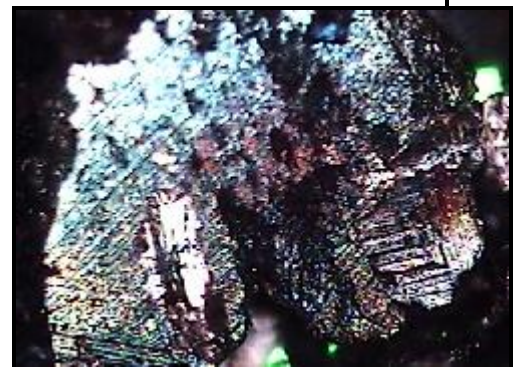
Ferrogram Oil Filter Media Contaminates

Hard Particle Damaged Heat Coloured Abrasive White Metal, & Copper Wear Debris @ 200X Sized 2-250 µm

There was a heavy amount of heat damaged metallic wear debris present in the sample

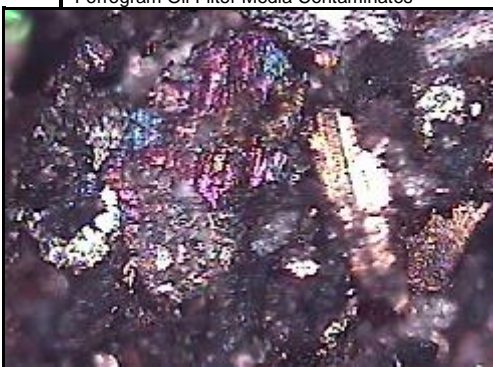
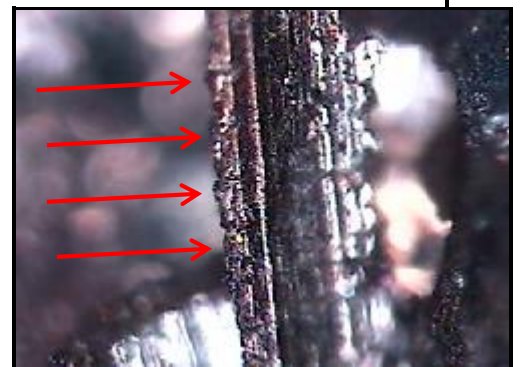
Ferrogram Oil Filter Media Contaminates

Hard Particle Damaged Heat Coloured Abrasive White Metal, & Copper Wear Debris @ 200X Sized 2-250 µm

There was a heavy amount of heat damaged metallic wear debris present in the sample

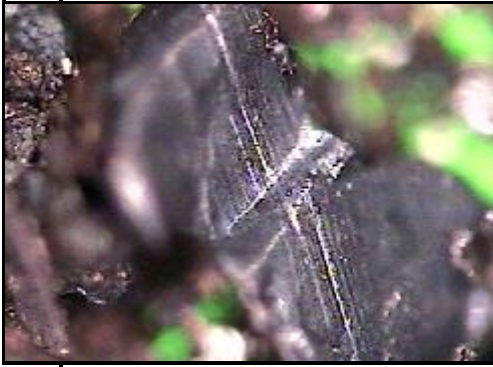
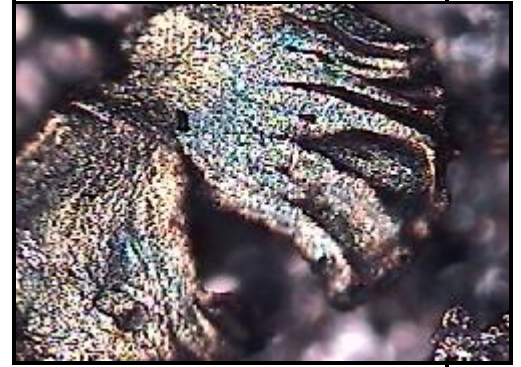
Hard Particle Damaged White Metal, & Copper Wear Particles @ 100X/200X Sized 2-500 µm

These wear particles indicate how the failure occurred. These large intact white metal particles are produced when the ingested hard particles slit the white metal embedment layer and the lubricant becomes trapped under the white metal layer.

Looking at wear debris after the failure is always difficult to find the root cause because of the amount of melted damaged metallic wear debris and in this instance the presence of the large pieces of intact white metal overlay indicating this was the first step in the failure.

If oil starvation or over heating was the primary cause of failure we don't find these large intact white metal particles because these areas melt and no intact particles are found.

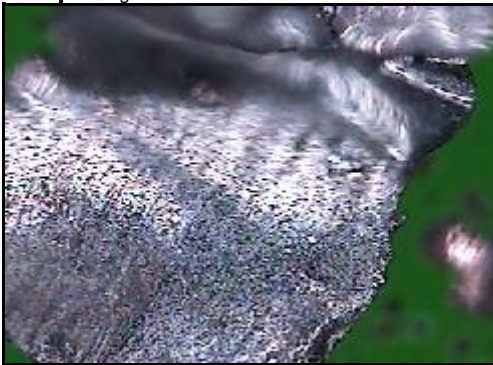
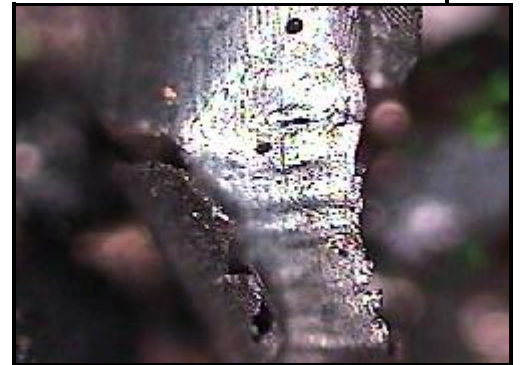
Hard Particle Damaged White Metal, & Copper Wear Particles @ 100X/200X Sized 2-500 µm

Once the white metal overlay is slit the lubricant trapped under the white metal is hydraulic along under the bearing face with the next revolution of the crankshaft bearing overlay then ejected out of the bearing journal on into the sump.

Once these large pieces of the white metal bearing overlay were hydrauliced off the bearings the increase in clearance caused a rapid failure of the bearing.

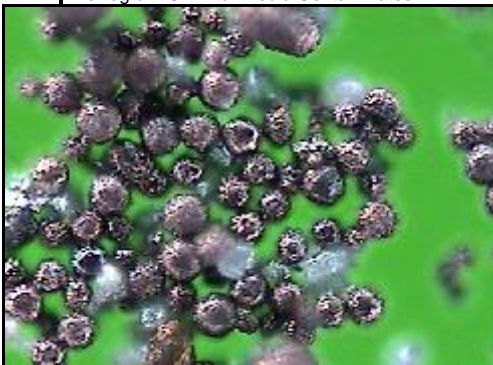
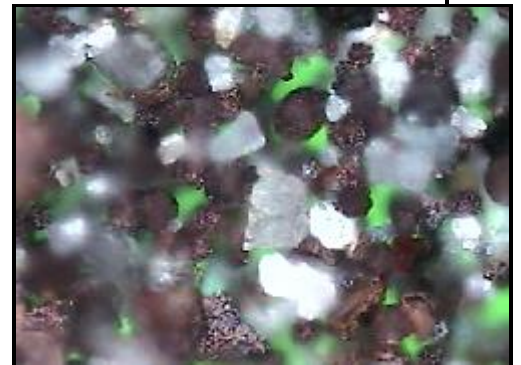
Hard Particle Damaged White Metal, & Copper Wear Particles @ 200X Sized 2-55 µm

These four images indicate the hard particles that caused the failure plus the amount of melted bearing material present shows the failure most likely was rapid and without any warning noticeable for the operator.

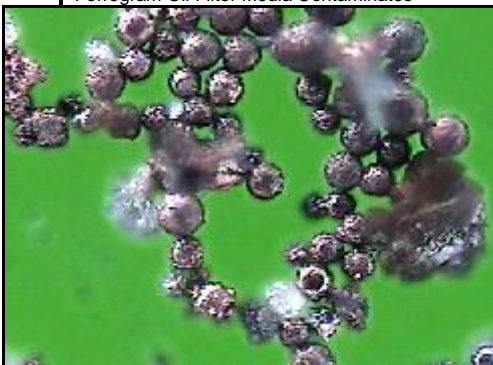
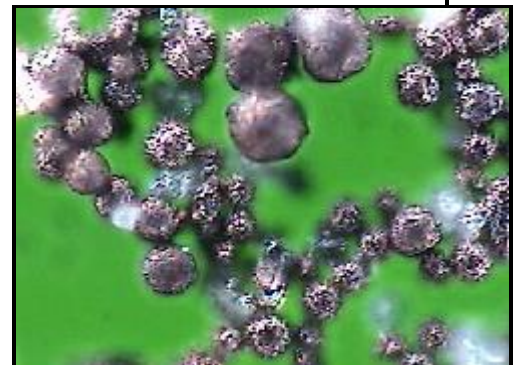
Melted White Metal. Copper Wear Spheres and Hard Silica Type Crystals @ 200X Sized 2-55 µm

There was a heavy amount of heat damaged metallic wear debris and this hard environmental contaminate present in the sample.

Once the bearing shell had lost the white metal overlay the increase in big end bearing clearance catalysed a rapid big end failure with melted bearing metal, damaged lubricant and hard environmental silica type crystals found in the oil filter.

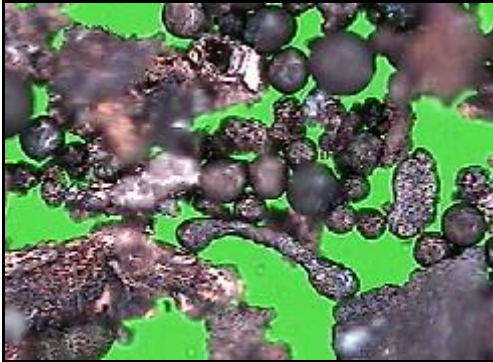
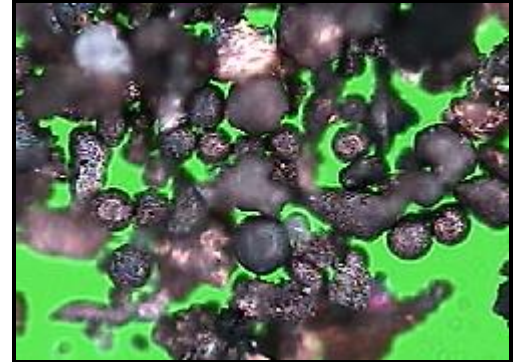
Ferrogram Oil Filter Polishing Stack Contaminates

Heat Damaged Lubricant & Metallic Wear Debris @ 200X Sized 2-60 µm

There was a moderate amount of this wear debris present in the sample.

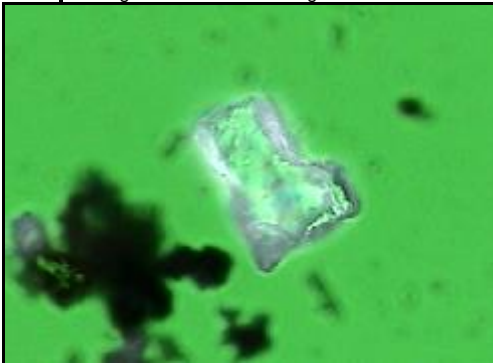
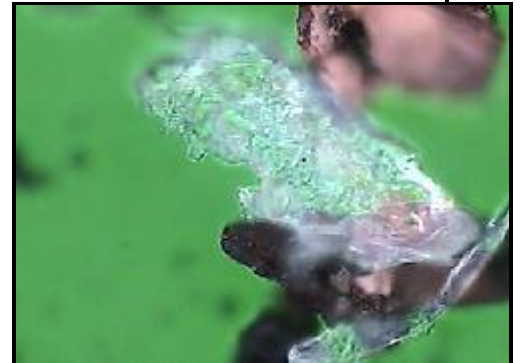
Ferrogram Oil Filter Polishing Stack Contaminates

Hard Inorganic Silica Type Crystals @ 500X Sized 5-90 µm

There was a light to moderate amount of this hard environmental contaminate present

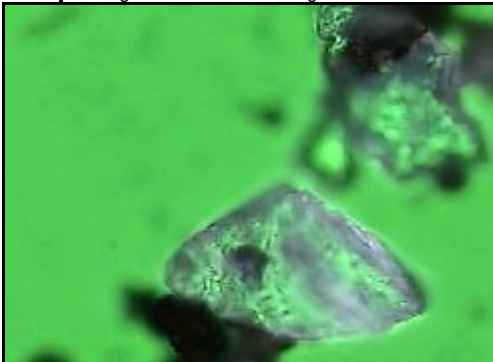
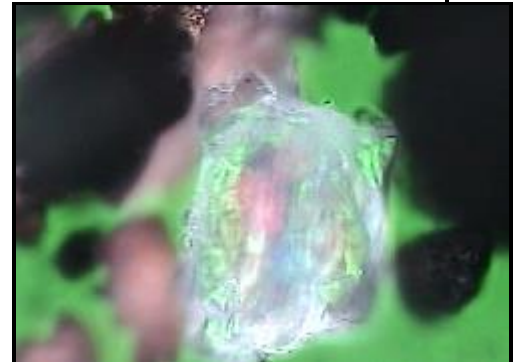
Ferrogram Oil Filter Polishing Stack Contaminates

Hard Inorganic Silica Type Crystals @ 500X Sized 5-90 µm

There was a light to moderate amount of this hard environmental contaminate present

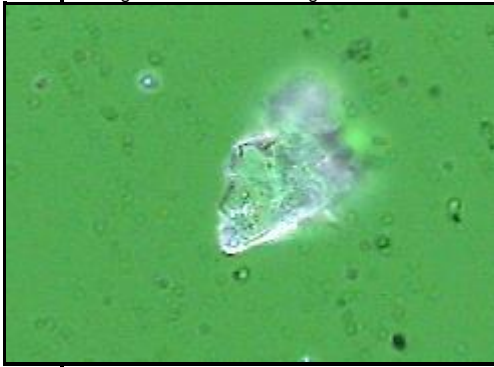
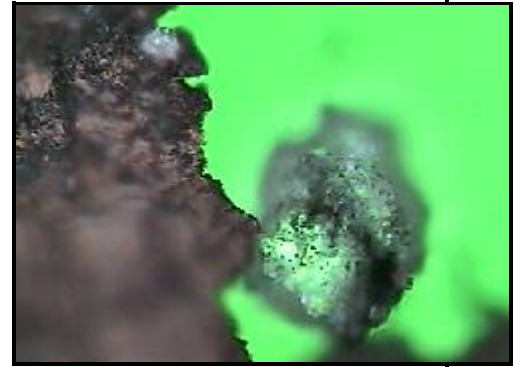
Ferrogram Oil Filter Polishing Stack Contaminates

**Hard Inorganic
Silica Type Crystals
@ 500X Sized 5-55 µm**

There was a light to moderate amount of this hard environmental contaminate present

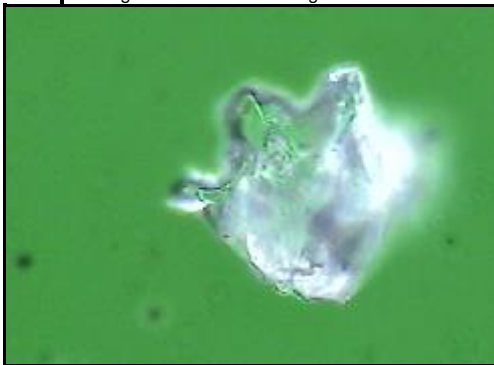
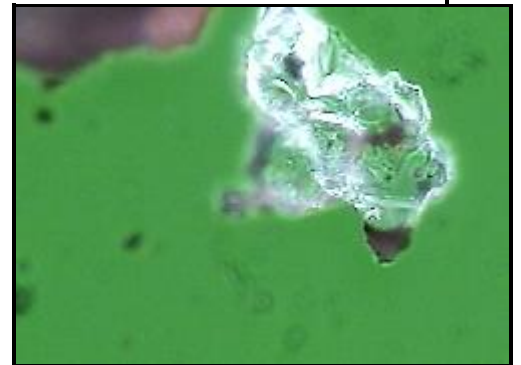
Ferrogram Oil Filter Polishing Stack Contaminates

**Hard Inorganic
Silica Type Crystals
@ 500X Sized 5-55 µm**

There was a light to moderate amount of this hard environmental contaminate present
