WDA No 000 BFMA

Objective. Crankcase Breather Filter Media Analysis Sample from 15/12/2014.

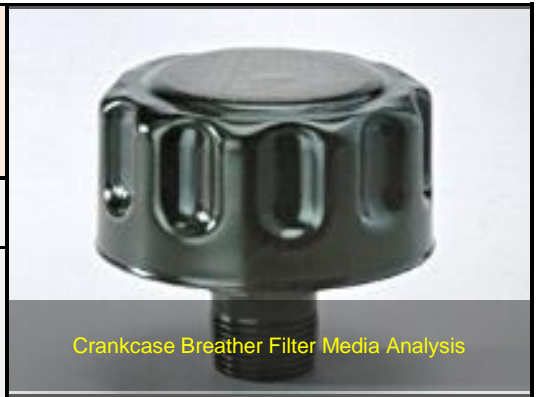
The left hand image indicates the condition of the exterior of the filter upon receipt.

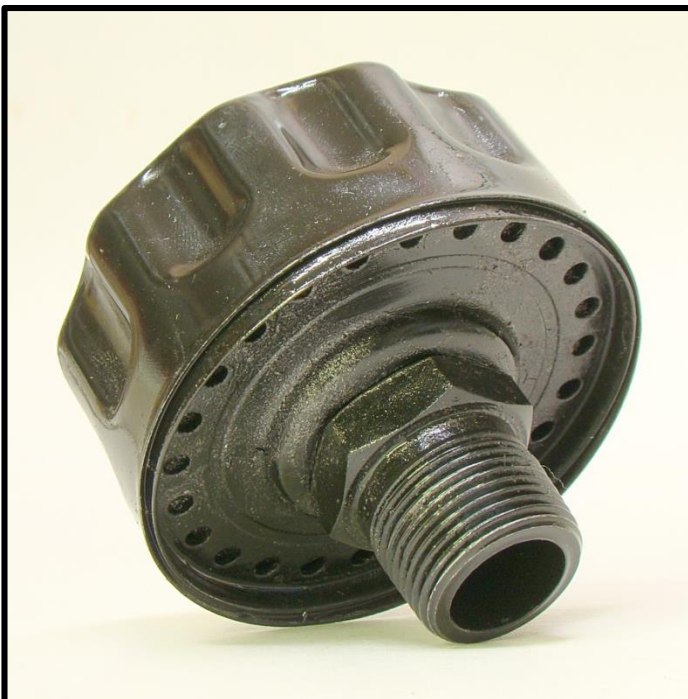
The Filter has been opened previous to receipt at the lab and was easily disassembled as the image below shows,

The dessicant pad and the media were both heavily oil soaked.

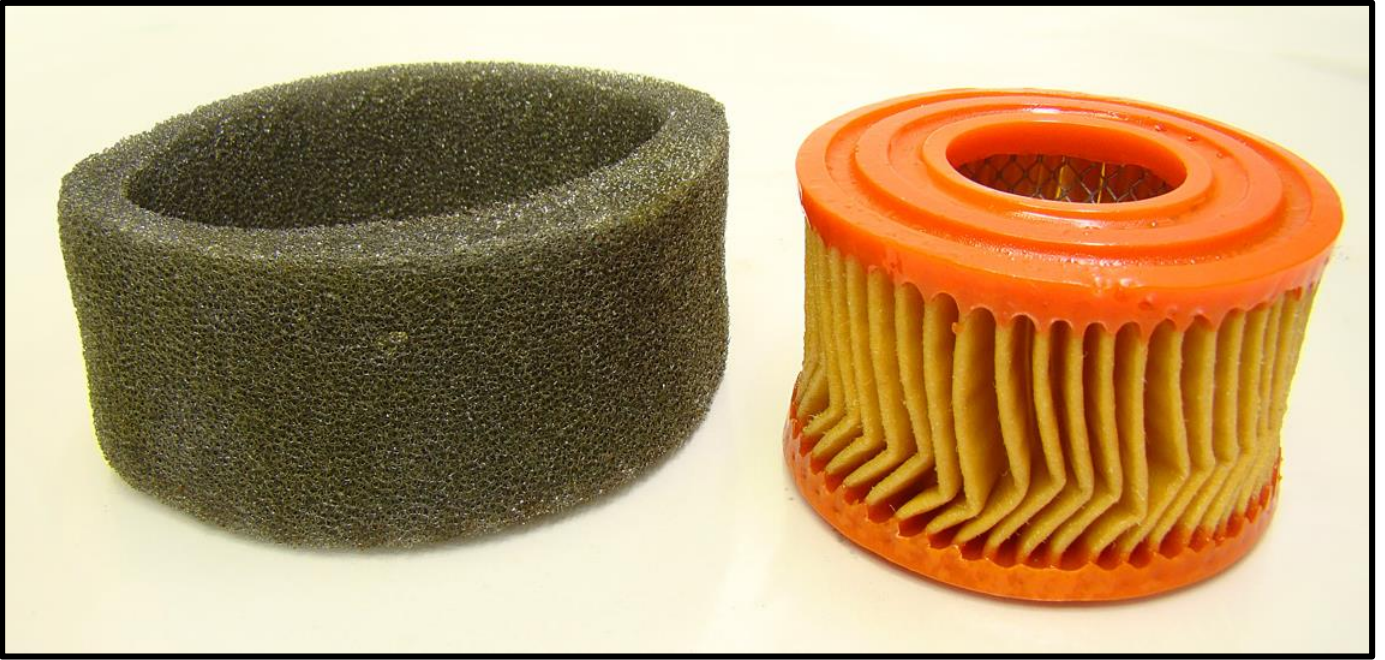
The Outer Foam Pre Filter and the pleated particulate filter were both heavily saturated with lubricant

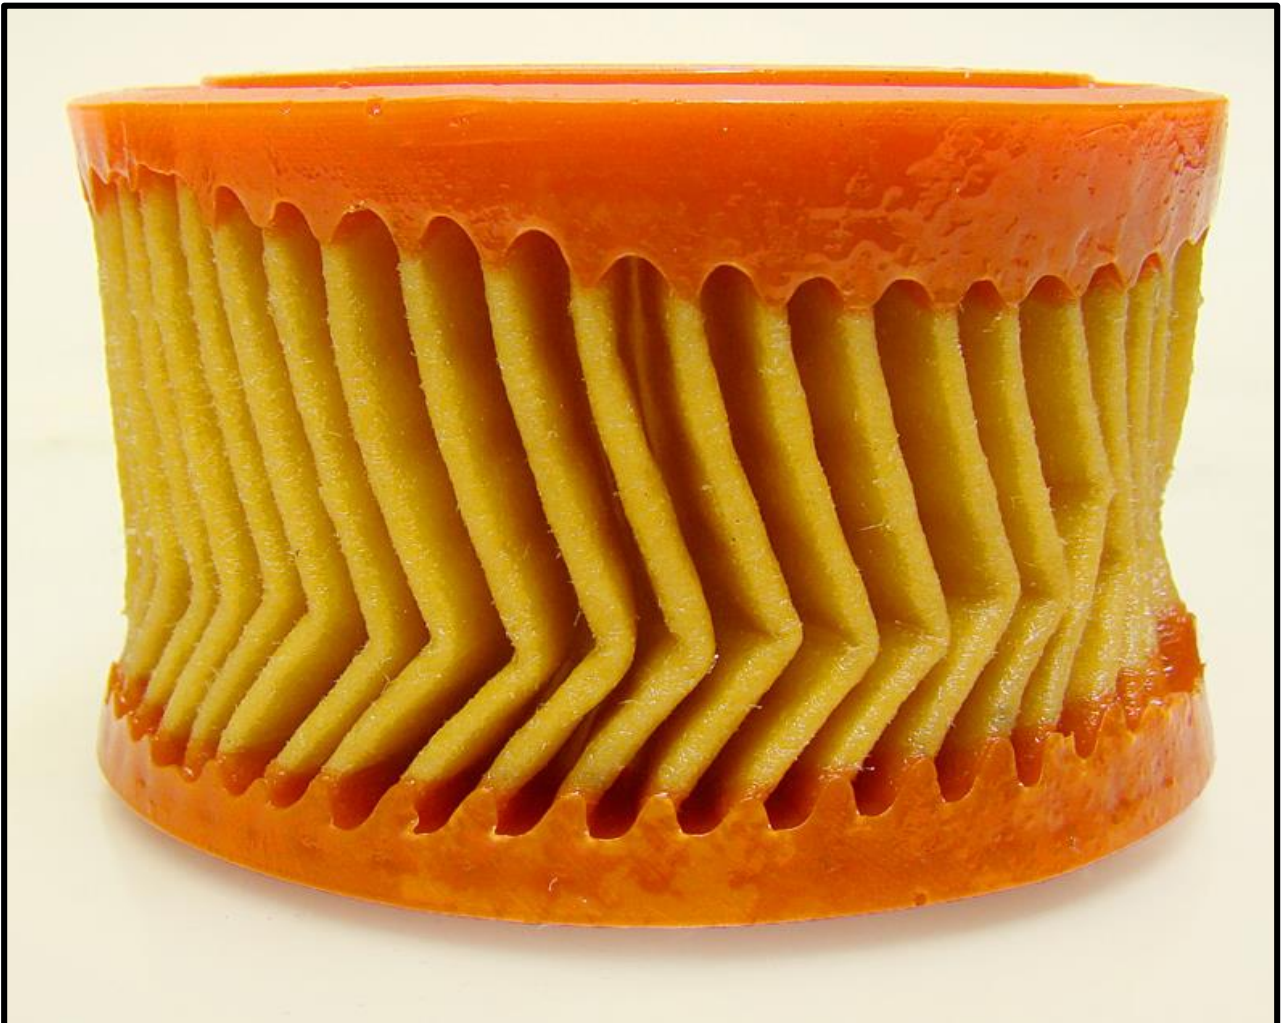
The 3 μm Pleated Particulate Filter Media Cartridge was visible distorted, we are unsure if this occurred during the initial disassembly of the filter for analysis or the breather filter media was compressed in this manner after being clogged with compressor lubricant.

The heavy saturation of lubricant choked the media off and it appears the pressure has collapsed the media cartridge as noted on page 2.

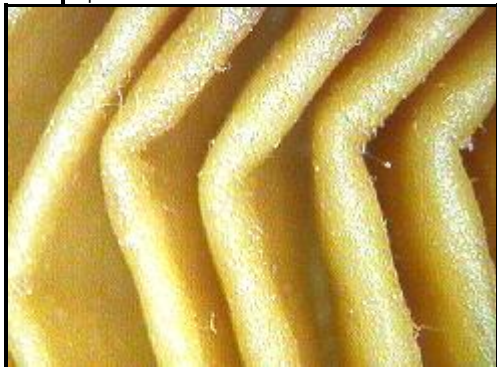
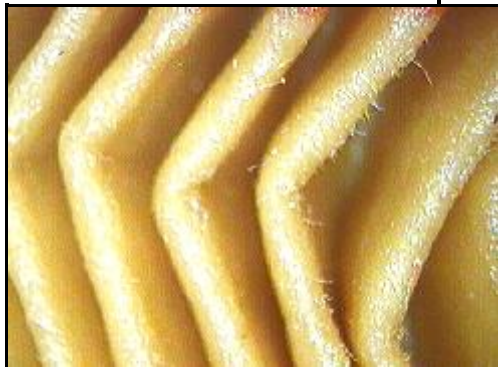
3µm Membrane Filter Breather Filter Media

Note how the breather filter media is heavily saturated with lubricant.

If the breather filter were to be shifted from the compressors crankcase onto the compressors sub frame using a metal pipe to assist with coalescing lubricant vapours that may prevent the heavy oil saturation found in the compressors crankcase breather filter.

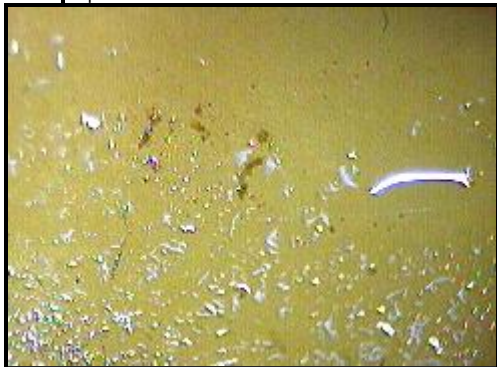
**Breather Filter
3 µm Outer Media Close Up
@ 50X/20X**

The breather filter media was heavily saturated with lubricant.

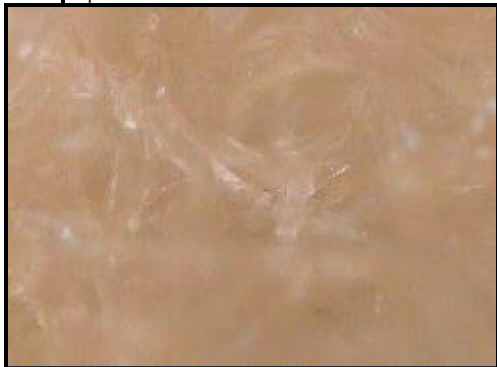
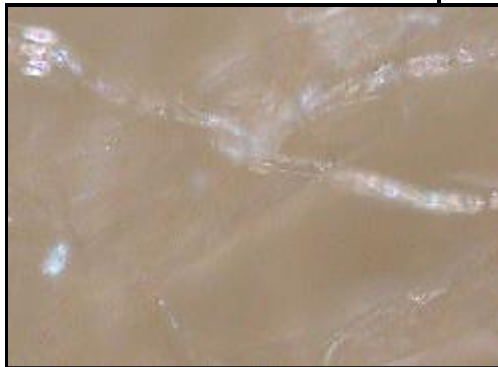
**Breather Filter
3 µm Inner Media Close Up
@ 100X/200X**

The breather filter media was heavily saturated with lubricant.

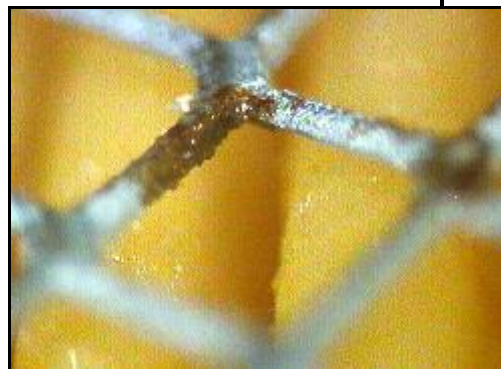
**Breather Filter Media
Support Aluminium Mesh
@ 20X/45X**

It was noted there were a few areas
on the Breather Filter Media plated
with heat damaged gelled
Lubricant.

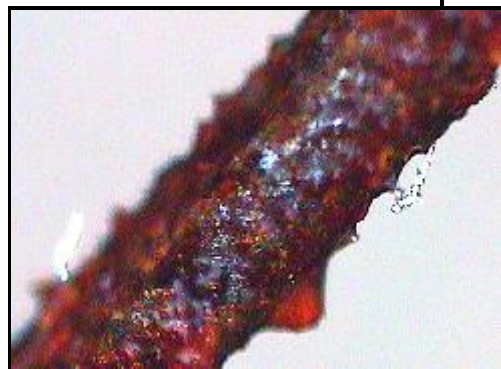
**Breather Filter Media
Support Aluminium Mesh
@ 100X/200X**

It was noted there were a few areas
on the Breather Filter Media plated
with heat damaged gelled
Lubricant.

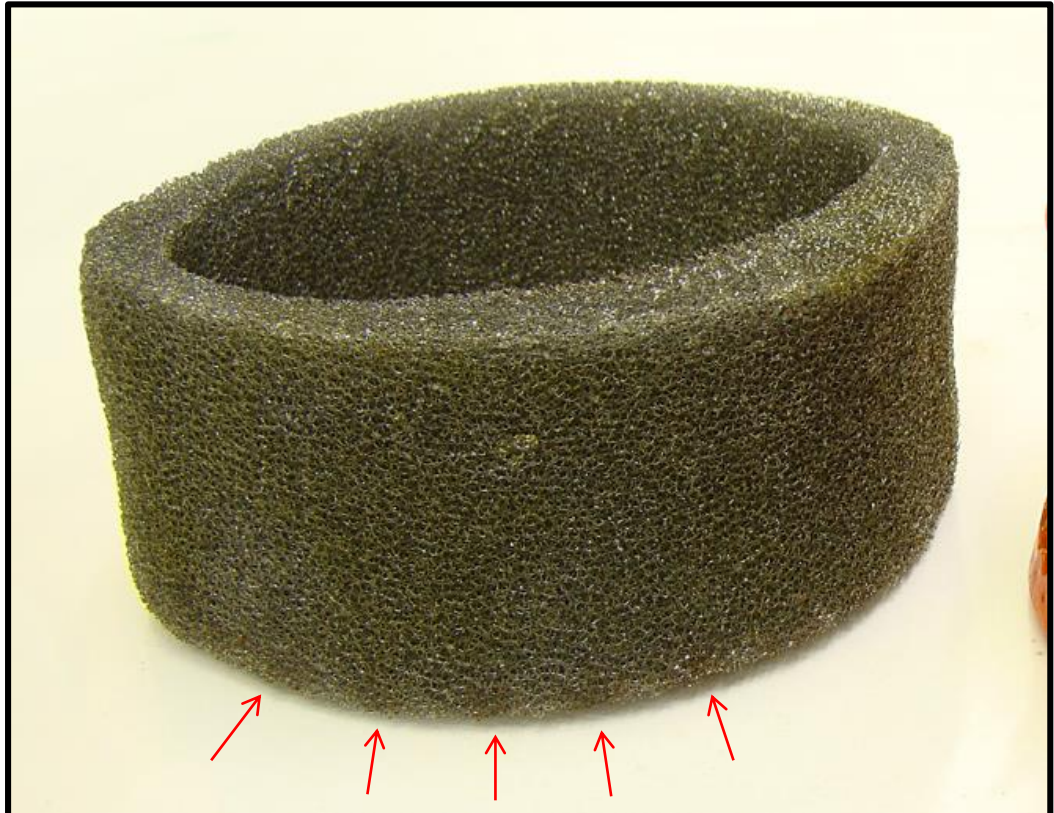
Breather Filter Outer Foam Pre Filter Media Analysis

Note the repetitive shading along base of the foam prefilter, these marks align with the vent holes in the under side of the breather filter cannister, the marks appear to be a combination of dirt and red iron oxides

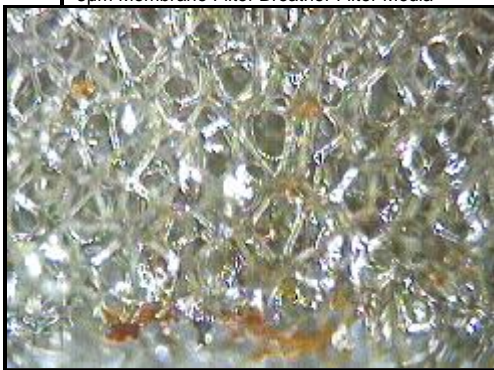
**Breather Filter
3 µm Outer Foam Pre-Media
@ 45X**

There was a mixture a gelled lubricant and red iron oxides adhering the prefilter.

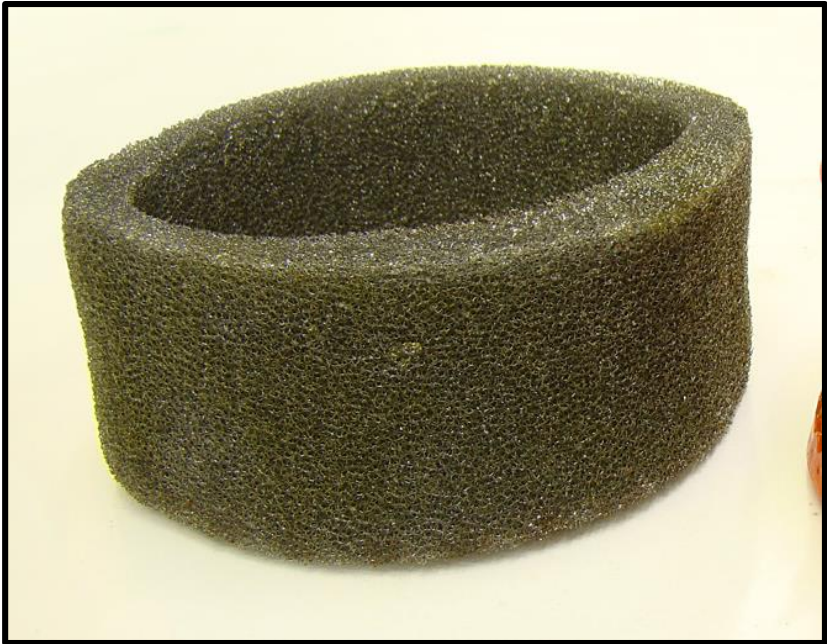
Breather Filter Outer Foam Pre Filter Media was next washed in prefiltered solvent and the washing fluid was filtered at 3 µm to extract the contaminants below.

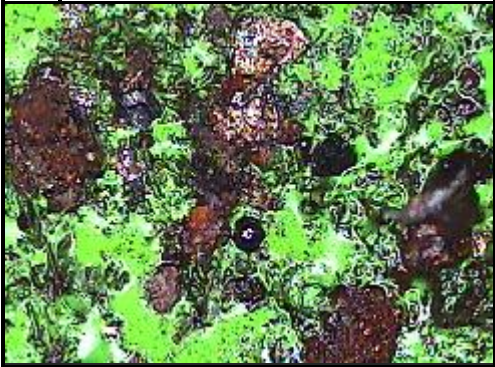
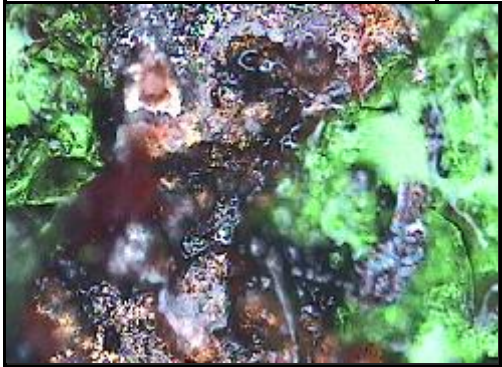
Trackside Two Body Ferrous Wear Debris and Carbonised Lubricant @ 500X Sized 0.5-120 µm

There was a moderate amount of this fine hard particle catalysed abrasive wear debris present.

The dirt and debris extracted on pages 6 & 7 is typical of trackside contamination with ferrous two body abrasive wear debris, wear spheres and copper, carbon & Graphite particles from the pantograph electrical contacts.

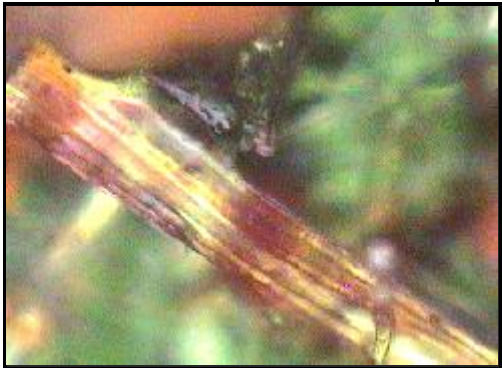
Trackside Organic Debris and Carbonised Lubricant @ 500X Sized 0.5-120 µm

There was a light to moderate amount of these organic fibres present

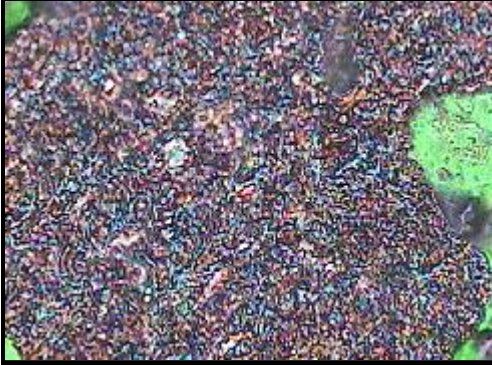
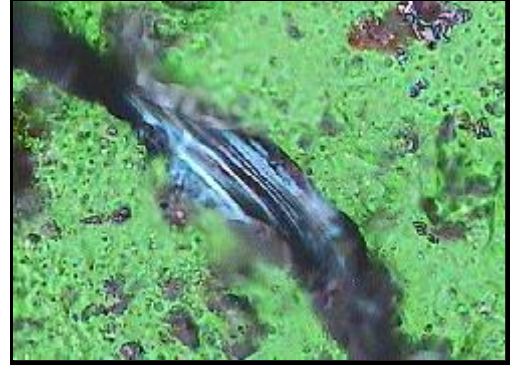
Trackside Two Body Ferrous Wear Debris and Carbonised Lubricant @ 500X Sized 0.5-120 µm

There was a moderate amount of this fine hard particle catalysed abrasive wear debris present.

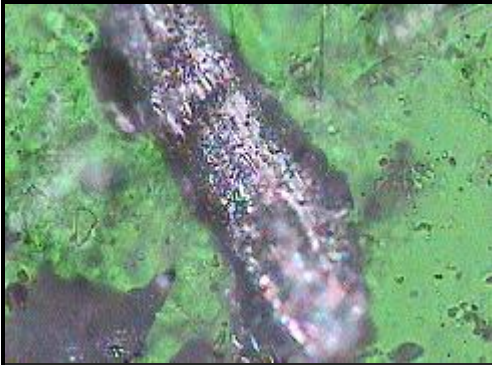
Trackside Two Body Ferrous Wear Debris and Carbonised Lubricant @ 500X Sized 0.5-120 µm

There was a moderate amount of this fine hard particle catalysed abrasive wear debris present.

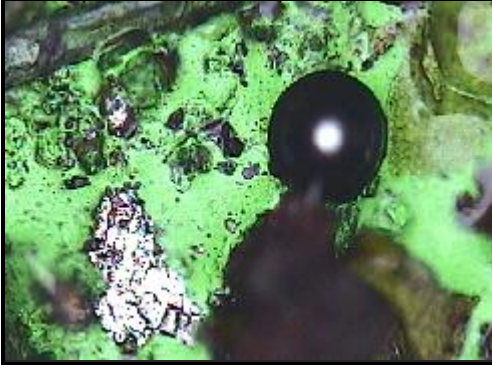
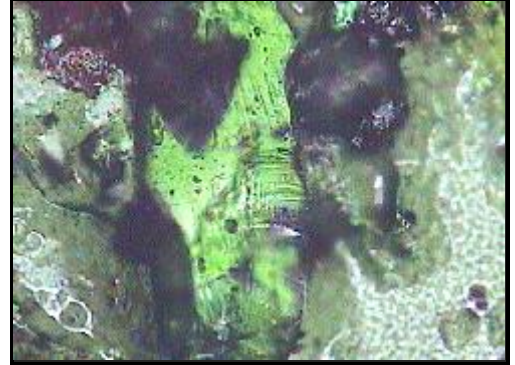
Trackside Two Body Ferrous Wear Debris and Carbonised Lubricant @ 500X Sized 0.5-120 µm

There was a moderate amount of this fine hard particle catalysed abrasive wear debris present.

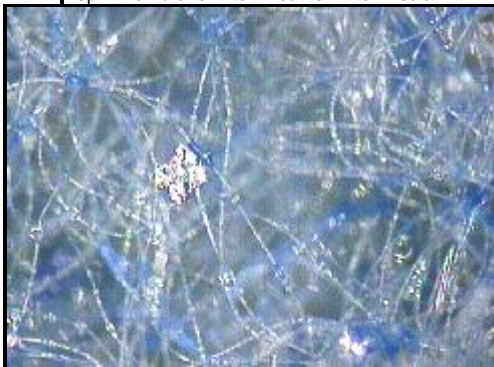
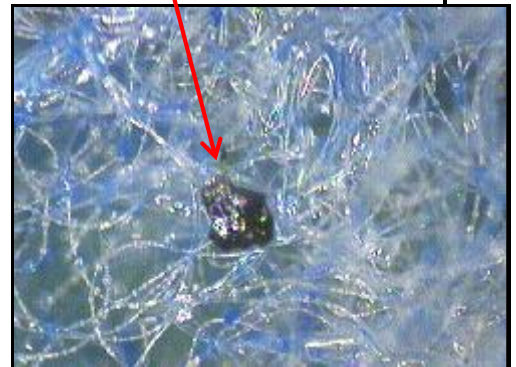
**Breather Filter
Desiccant Filter Pad
@ 45X**

The closer view of the Desiccant Filter Pad showed the were heat damaged lubricant particles caught in the media.

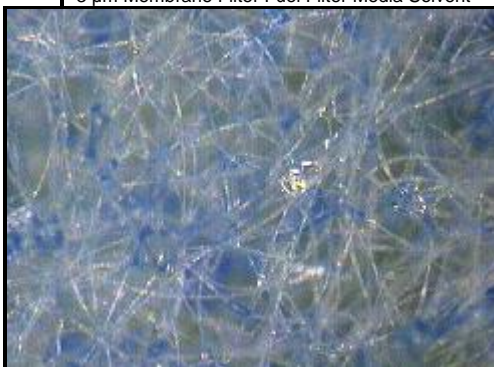
**Breather Filter
Desiccant Filter Pad
@ 45X**

The Desiccant Filter Pad is saturated with lubricant.
