WDA No 000 Cotton Harvester FEOFMA

Objective. Cotton Harvester Failed Engine Oil Filter Media Analysis Sample from 8/05/2014.

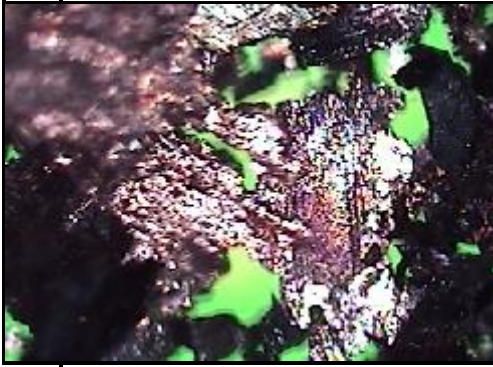
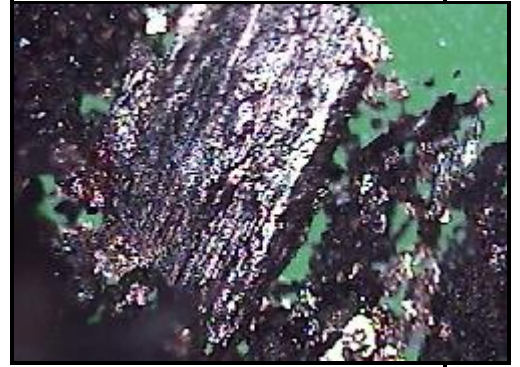
Ferrogram Oil Canister Contaminates

These images at 100X/200X indicate the average wear debris and contaminates deposited on the analysis filter from 1 CC of the sample forced through the 3- μ m Membrane Analysis Filter.

The brightness of microscopes bottom green/blue light shining up through the sample can provide an indication of the level of wear debris and contaminating particles per cc

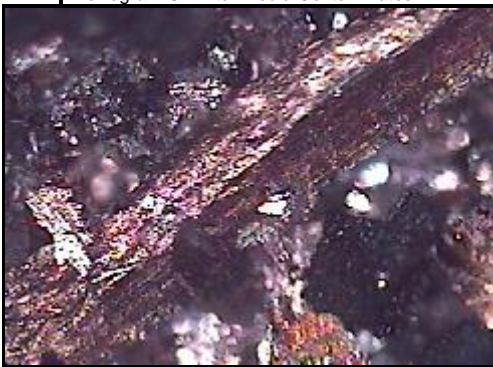
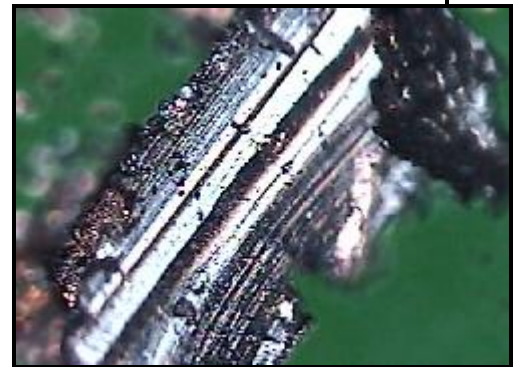
Ferrogram Oil Filter Media Contaminates

These images at 50X/200X indicate the average wear debris and contaminates deposited on the analysis filter from 1 CC of the sample forced through the 3-µm Membrane Analysis Filter.

The brightness of microscopes bottom green/blue light shining up through the sample can provide an indication of the level of wear debris and contaminating particles per cc

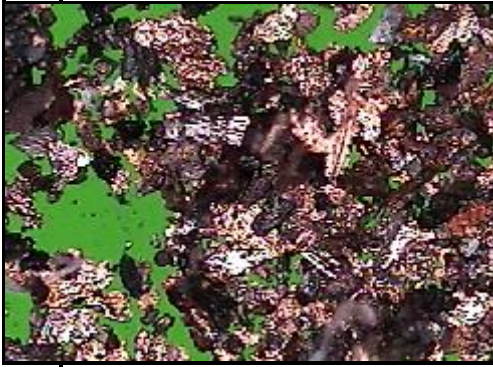
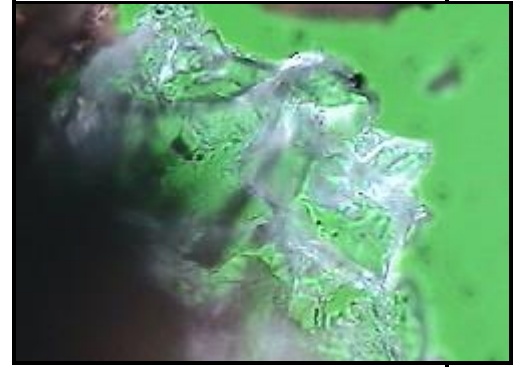
Ferrogram Oil Filter Polishing Stack Contaminates

These images at 100X/1000X indicate the average wear debris and contaminants deposited on the analysis filter from 1 CC of the sample forced through the 3-µm Membrane Analysis Filter.

The brightness of microscopes bottom green/blue light shining up through the sample can provide an indication of the level of wear debris and contaminating particles per cc
